Harness Structural test Report - NfL

Inspection certificate number: PH_367.2022

Name: **Delight 4 Sport**
 Type: **ABS**
 Size: **M**
 Serial number: **2172MM0602RO#14**
 Impact pad type: ⁽¹⁾ **Foam**
 Clip-in weight [kg]: **130**
 Integrated container: **Yes**
 Date of test: **22.08.2022**

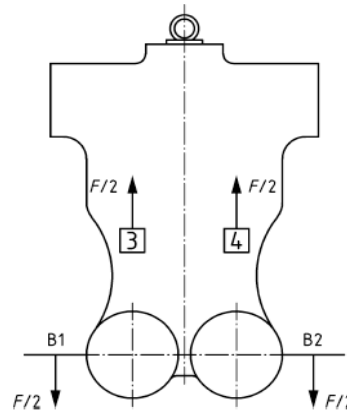
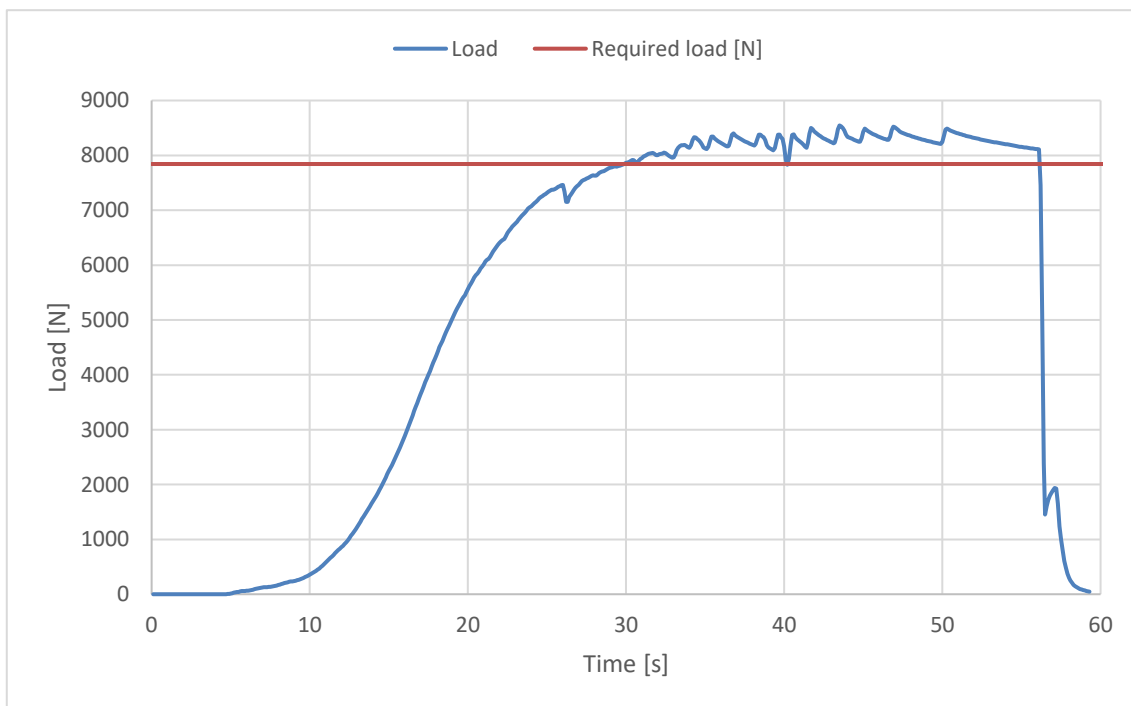
Test ID 02

Standard **NfL 2-565-20**
 Reference **5.3.2.1**
 Test setup **Default flying position**
 Attachment points **Both main riser attachment (3,4)**
 Anchor points **Dummy (B1, B2)**

Required load [g] **6**
 Required load [N] **7800**
 Minimum test duration [s] **10**

Test duration [s] **15.9**
 Any signs of structural failure **No**
 Test results **POSITIVE**

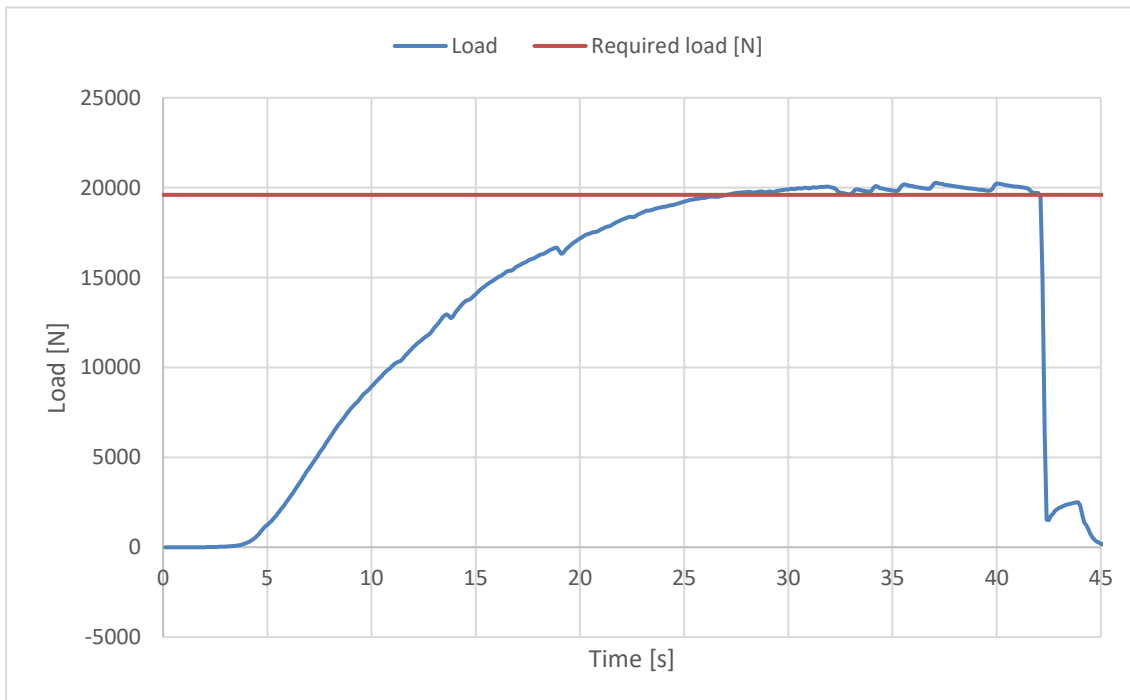
Test ID 03

Standard	NfL 2-565-20
Reference	5.3.2.2
Test setup	Default flying position
Attachment points	Both main riser attachment (3,4)
Anchor points	Dummy (B1, B2)
Required load [g]	15
Required load [N]	19500
Minimum test duration [s]	5
Result	
Test duration [s]	15
Any signs of structural failure	No
Test results	POSITIVE

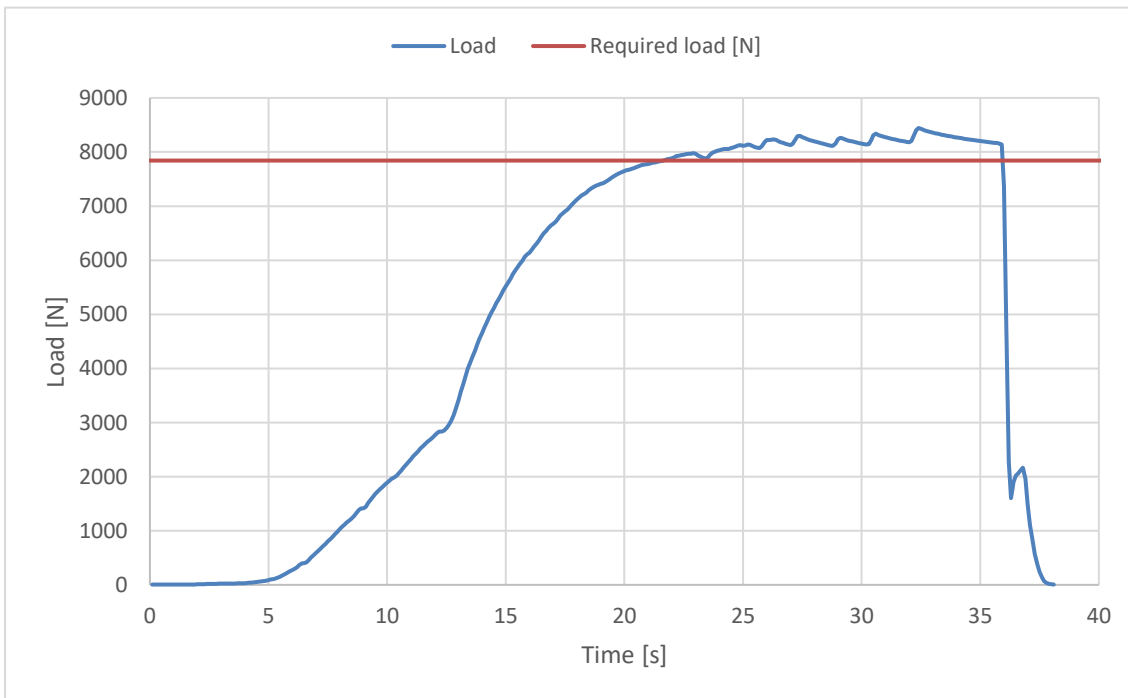
Test ID 04

Standard **NfL 2-565-20**
 Reference **5.3.2.3**
 Test setup **Asymmetric, one riser**
 Attachment points **One main riser attachment (3)**
 Anchor points **Dummy (B1,B2)**

Required load [g] **6**
 Required load [N] **7800**
 Minimum test duration [s] **10**

Test duration [s] **14.3**
 Any signs of structural failure **No**
 Test results **POSITIVE**

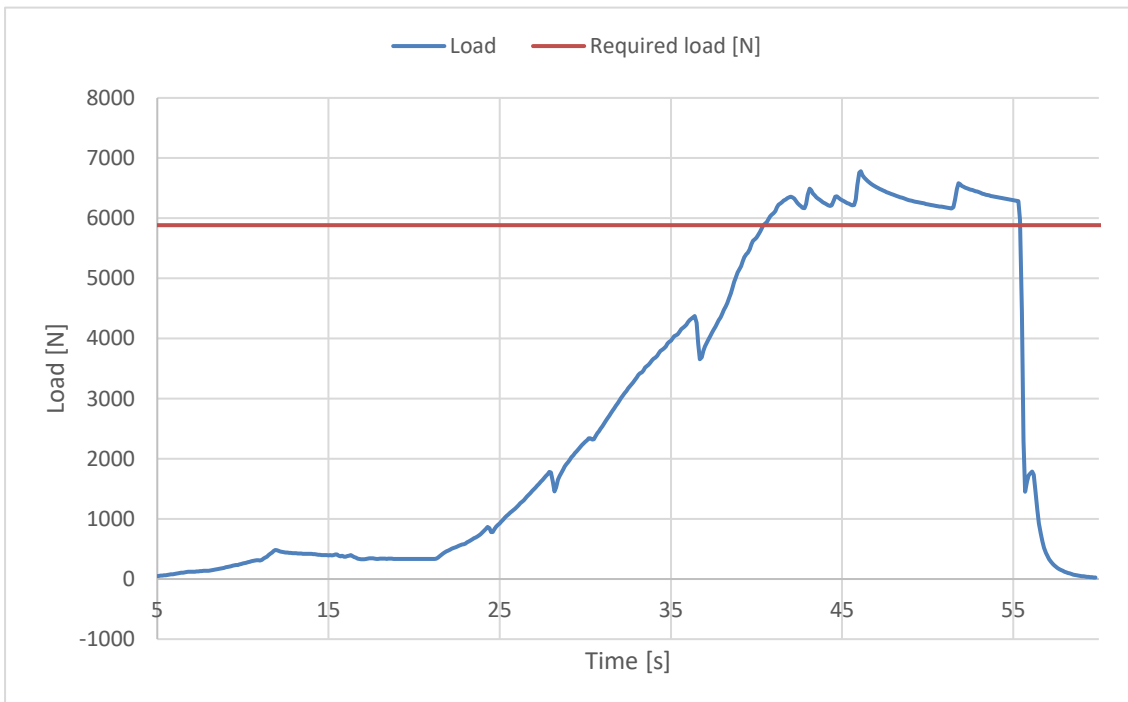
Test ID 07

Reference	5.3.2.6	
Test setup	Asymmetric, negative	
Attachment points	One main riser attachment (3 or 4) downwards	
Anchor points	Dummy (9)	
Required load [g]	4.5	
Required load [N]	5850	
Minimum test duration [s]	10	
Result		
Test duration [s]	15	
Any signs of structural failure	No	
Test results	POSITIVE

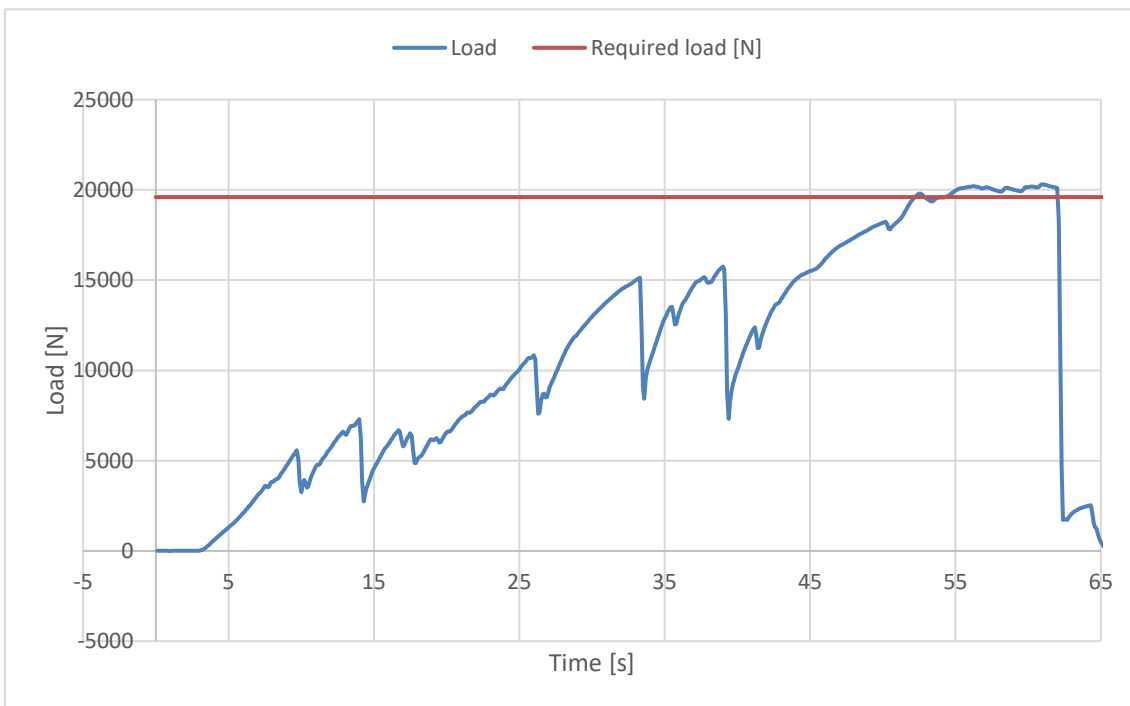
Test ID 09

Standard	NfL 2-565-20
Reference	5.3.2.4
Test setup	Rescue attachments
Attachment points	Rescue riser attachment (1,2)
Anchor points	Dummy (B1,B2)
Required load [g]	15
Required load [N]	19500
Minimum test duration [s]	5
Result	
Test duration [s]	7.7
Any signs of structural failure	No
Test results	POSITIVE

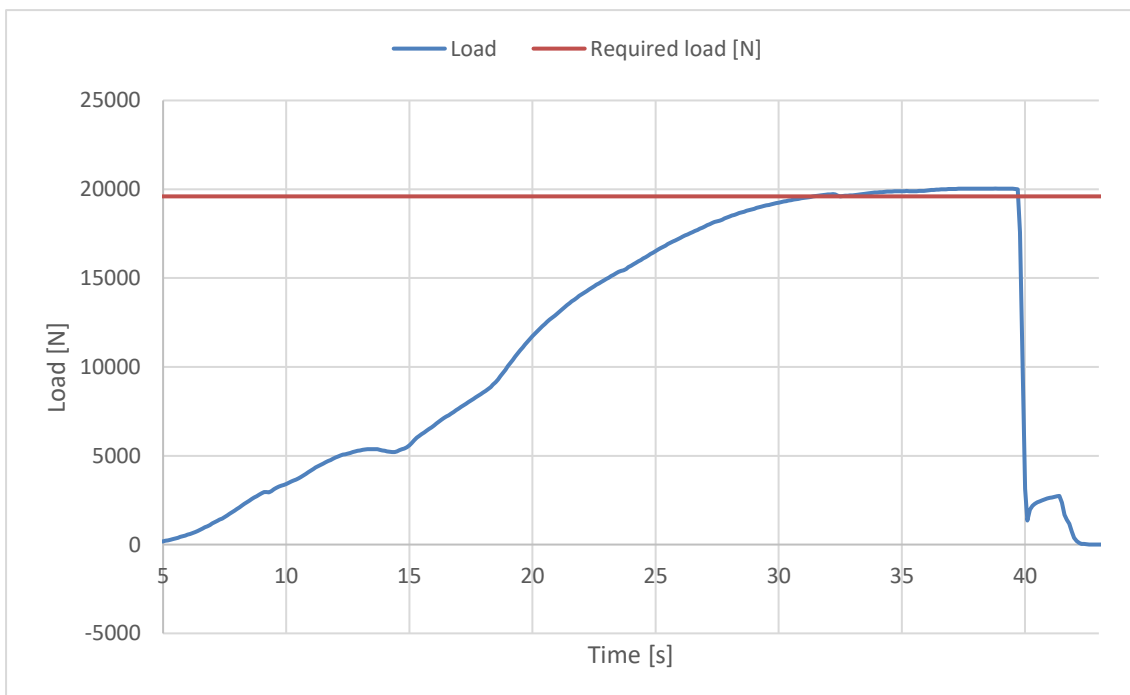
Test ID 13

Standard	NfL 2-565-20
Reference	5.3.2.7
Test setup	Flying position before landing
Attachment points	Both main riser attachment (3,4)
Anchor points	Dummy (7,8)
Required load [g]	15
Required load [N]	19500
Minimum test duration [s]	5
Result	
Test duration [s]	8.3
Any signs of structural failure	No
Test results	POSITIVE

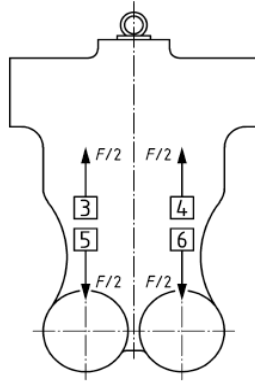
Test ID 14

Reference	5.3.2.5	
Test setup	Towing	
Attachment points	Both main riser attachment (3,4)	
Anchor points	Both tow release points (5,6) -direction of towing cable	
Required load [g]	5	
Required load [N]	6500	
Minimum test duration [s]	10	
Result		
Test duration [s]	0	
Any signs of structural failure	No	
Test results	n/a

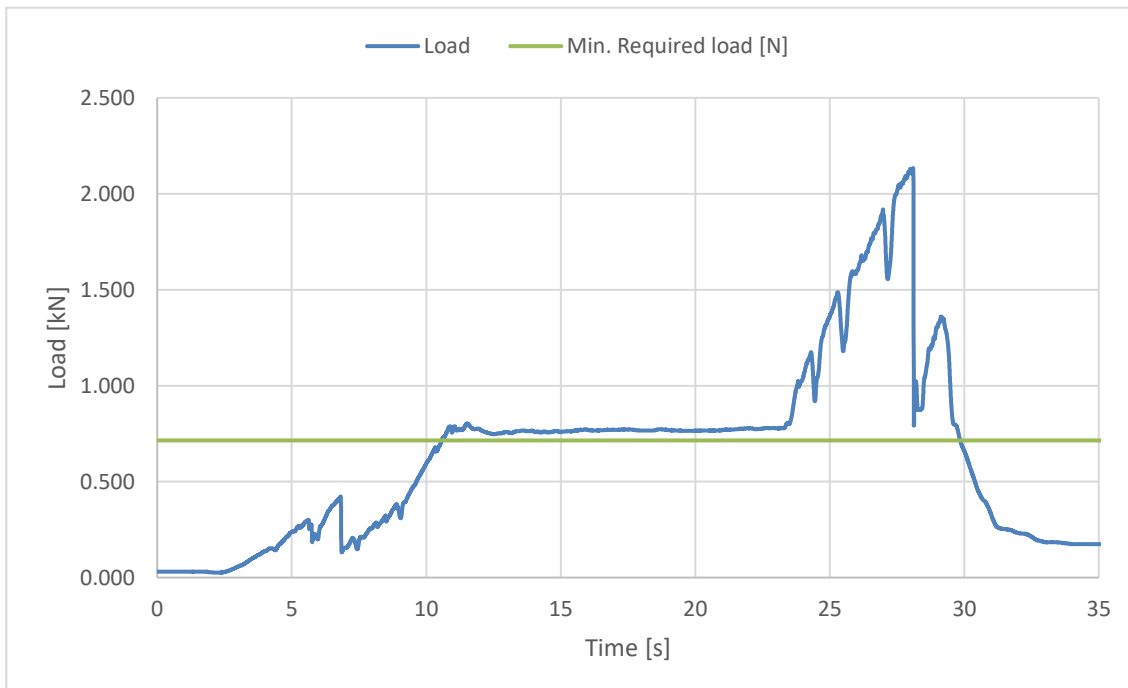
Test ID RRST

Standard	EN12491:2015
Reference in standard	5.3.2
Test setup	Two end points of handle
Attachment points	Sensor connect to end of handle, pull on the other side
	The handle must support min 700 N for 10 s, after measure breaking strength
Min. Required load [N]	700
Minimum test duration [s]	10
Result	
Test duration [s]:	19.3
Breaking strength [N]	2120.82
Test results	POSITIVE
